Intraoperative Guide Wire Breakage during Intertrochanteric Fracture Fixation: A Technical Complication and Management Strategy

Case Report: We report a case of intraoperative guide wire breakage during reaming for cephalomedullary nailing in a 65-year-old female with an intertrochanteric femur fracture. The broken guide was embedded within the femoral neck and managed intraoperatively.

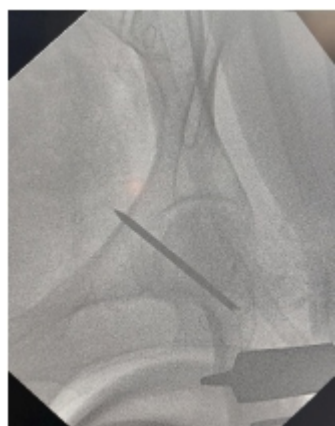
During cephalomedullary nailing, while reaming over the guide wire for the proximal lag screw, resistance was encountered followed by sudden loss of resistance. Fluoroscopic imaging revealed a broken guide wire lodged in the femoral neck (Fig. 1, 2). Attempts at removal with a pituitary rongeur were unsuccessful (Fig. 3).

Figure 1: Guidewire broken

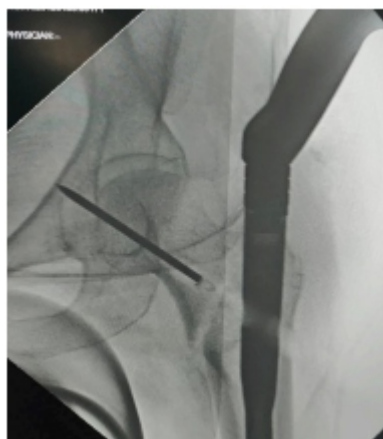
Figure 2: Guidewire Broken while reaming

- **Material Fatigue:** Repeated use of guide wires beyond recommended cycles leads to metal fatigue [3].
- **Forceful Reaming:** Excessive resistance during reaming, especially in sclerotic bone, may transmit shearing stress to the wire.
- **Improper Trajectory:** Misalignment increases the chance of binding and stress concentration.
- **Reuse of Instruments:** Repeated autoclaving and sterilization can degrade metallic integrity [4].

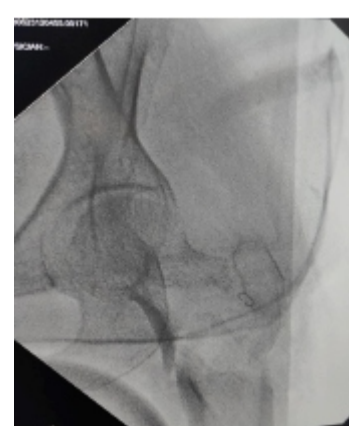
Figure 3: Guidewire Removed

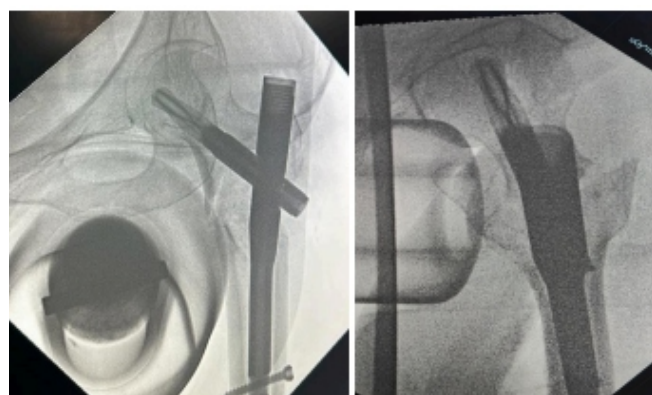
Figure 4, 5: Guidewire Removed and PNF inserted AP/Lateral Views

The surgical team proceeded with careful re-reaming through a new trajectory and completed the procedure using a slightly altered entry point and Proximal Femoral Nail was inserted (Fig. 4, 5). The patient was informed postoperatively, and serial radiographs showed no migration. She progressed to full
